Manhole Inspection Summary

Manhole # S47II_030MH

Insp Date: **5/1/08 12:34 PM**

Location Address: **Montford Ave**

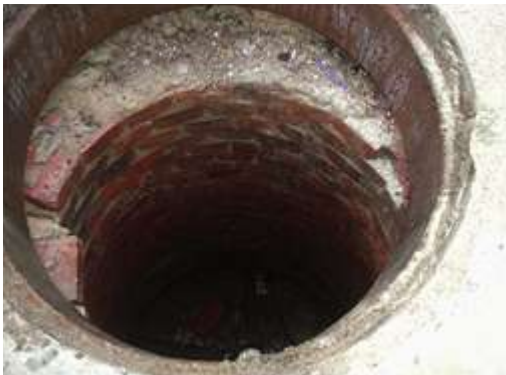
Defect 2

Infiltration: ☐ None ☐ Joint ☐ Cracks ☐ Mortar ☐ Roots ☒ **Wall**

Infiltration

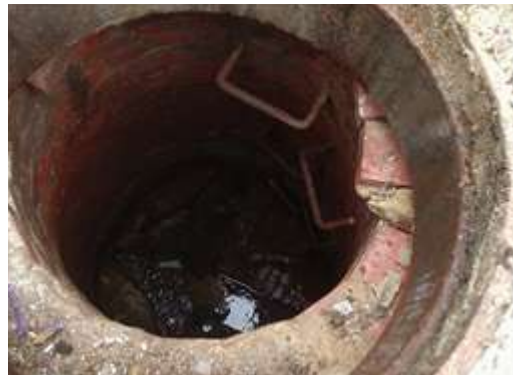
Defect 1

Condition: ☐ Sound ☐ Cracked ☐ Root Intrusion ☒ **Loose Brick** ☐ Deteriorated

Infiltration: ☐ None ☒ **Joint** ☐ Cracks ☒ **Mortar** ☐ Roots ☐ Wall

Loose Bricks

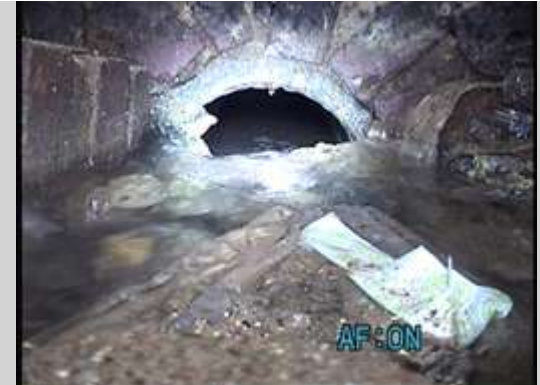
12 O'Clock Outflow

8 in. Circular Gravity Sewer
Pipe Out @ 12 O'Clock

Pipe Height: **8.4** (in.) Rod and Bar (Angled)
Pipe Material: **Clay** ☐ Pipe Lined
Invert Depth: **9.85** (ft.) Flow Characteristics: **Fast**
Deposits: ☐ None ☐ Mud ☐ Sludge ☒ **Debris** ☐ Grease
Silt Depth: **4** (in.) Deposits Extent: **Medium**
Infiltration: **None** Pipe Seal Cond: **Sound**

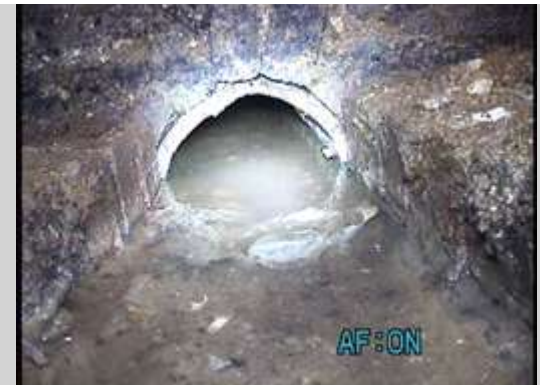
3 O'Clock Inflow

8 in. Circular Gravity Sewer
Pipe In @ 3 O'Clock

Pipe Height: **8.4** (in.) Rod and Bar (Angled)
Pipe Material: **Clay** ☐ Pipe Lined
Invert Depth: **9.70** (ft.) Flow Characteristics: **Slow**
Deposits: ☒ **None** ☐ Mud ☐ Sludge ☐ Debris ☐ Grease
Silt Depth: (in.) Deposits Extent:
Infiltration: **None** Pipe Seal Cond: **Sound**

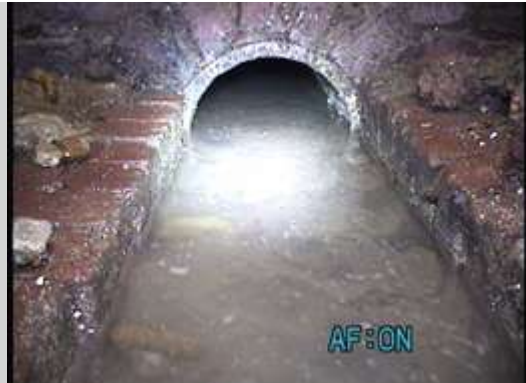
6 O'Clock Inflow

8 in. Circular Gravity Sewer

Pipe In @ 6 O'Clock

Deposits: ☒ None ☐ Mud ☐ Sludge ☐ Debris ☐ Grease

Infiltration: **None** Pipe Seal Cond: **Sound**

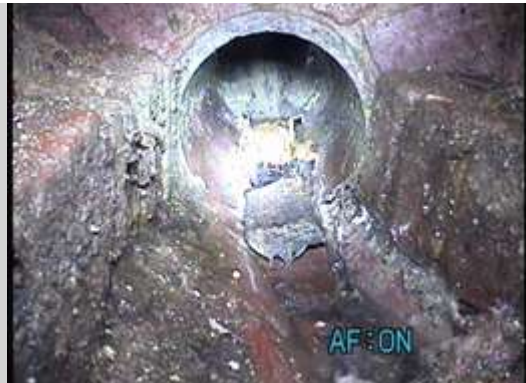
9 O'Clock Inflow

6 in. Circular Gravity Sewer

Pipe In @ 9 O'Clock

Deposits: ☒ None ☐ Mud ☐ Sludge ☐ Debris ☐ Grease

Infiltration: **None** Pipe Seal Cond: **Sound**

Connects To: **House connection / Service line**
